# **Flight Test Experience and Controlled Impact of a Large, Four-Engine, Remotely Piloted Airplane**

Robert W. Kempel and Timothy W. Horton

August 1985

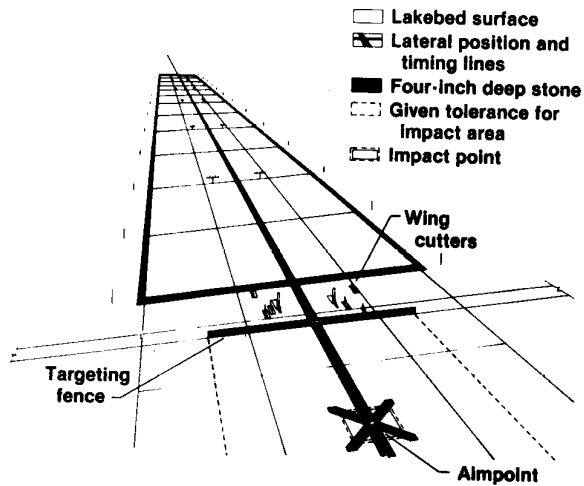
Figure 1. Controlled Impact Demonstration Aircraft Crash Site

Figure 1 shows the layout of the crash site. The triangular obstacles are "wing cutters," designed to open wing fuel tanks to ensure dispersal of AMK. The heavy horizontal line was a fence 2.4 m (8 ft) high, made of frangible material which aided the RPV pilot in the targeting task. Where the centerline intersects the fence, a bright orange panel was placed to provide the RPV pilot a visual guidance aimpoint.

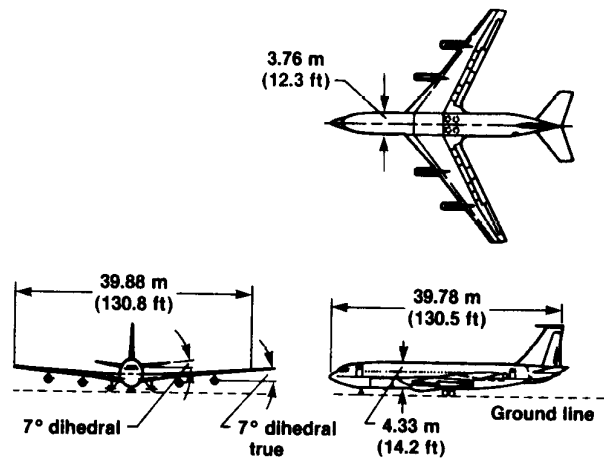
Figure 2. Three-View Drawing of B-720 Airplane

The Boeing B-720 airplane is a swept-wing, swept-tail, four-engine, medium-range jet transport. The principal physical dimensions of the B-720 are shown in Fig. 2. The approximate empty weight was 44,490 kg (98,000 lb) with a structural design gross weight of 92,160 kg (203,000 lb).

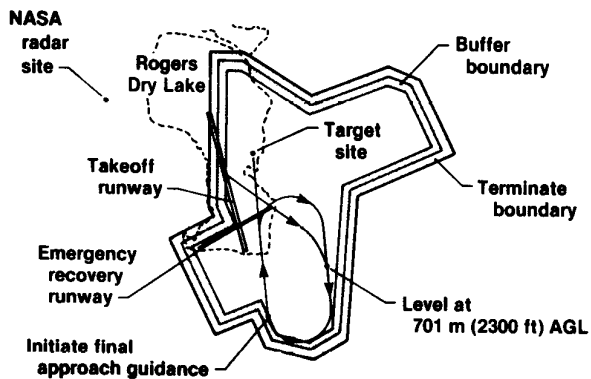
Figure 3. Controlled Impact Demonstration Ground Track and Sterile Area Boundary

The actual CID mission profile and boundary are presented in Fig. 3. The takeoff runway was lakebed runway 17 on Rogers Dry Lake. Following takeoff, the vehicle would make a gentle left-hand turn until it intersected the racetrack at approximately 700 m (2300 ft) above ground level (AGL) which was 1400 m (4600 ft) mean sea level (MSL). With the airplane level and on the racetrack, a right turn with a radius of 1.4 n. mi. was performed with a rollout on the impact runway heading. Final-approach glideslope guidance was

The terminate boundary is shown as the light boundary on the outside of the buffer (darker) boundary. If for any reason the aircraft strayed outside the buffer boundary, a terminate command would be transmitted through an independent system. This command consisted of a full nose-down stabilizer, right rudder, engine fuel shutoff, and gear down to insure that the vehicle would impact within the sterile area indicated by the terminate boundary.

Two modes of guidance information were provided to aid the RPV pilot in flying the B-720 aircraft. One mode, the racetrack guidance, assisted the pilot in flying the racetrack pattern. The second mode, final approach guidance, assisted the RPV pilot in flying the desired approach path and aided in attaining the desired conditions at impact. The racetrack and final approach patterns can be seen in Fig. 3.

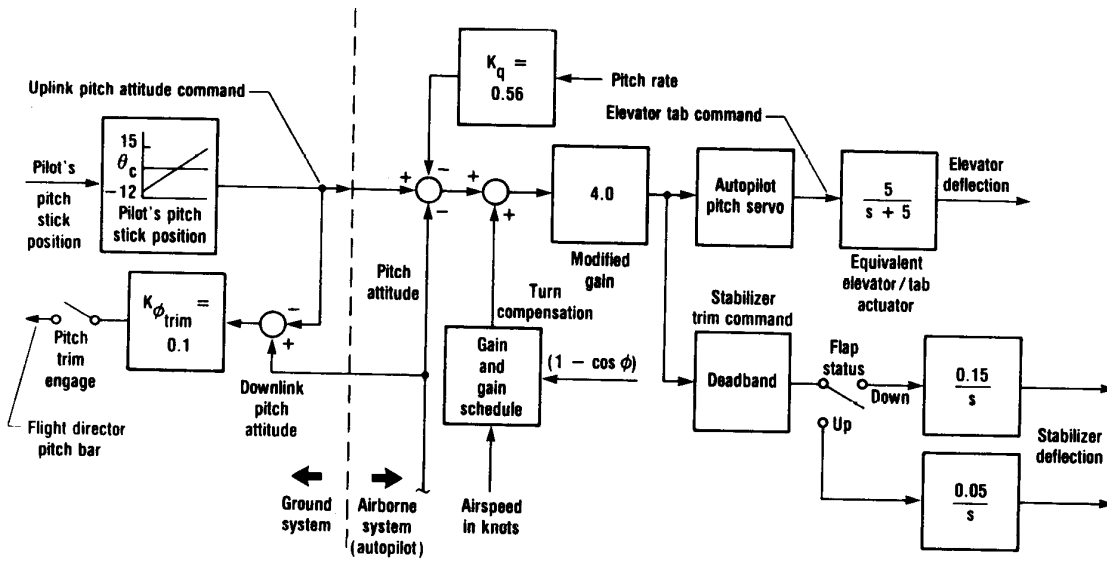
Figure 5. Controlled Impact Demonstration Ground and Airborne Pitch Control System

The control laws for the pitch axis are shown in Fig. 5. The RPV pilot commands pitch angle of the B-720 airplane by movement of a control stick in the ground-based cockpit. A pitch attitude command that was proportional to stick deflection was sent to the pitch axis of the PB-20D autopilot. Full stick deflection of  $\pm 10.16$  cm ( $\pm 4$  in.) commanded  $-12^\circ$  to  $+15^\circ$  of pitch angle. A pitch trim button was located on the RPV pilot's stick that moved the stick at a constant rate of  $2.9^\circ$  of pitch attitude per second.

Figure 5 also shows how the autopilot processed the uplink attitude command. The signal was summed with pitch angle and pitch rate feedbacks, and with a turn compensation term. The autopilot generated a command to the autopilot servo, which in turn deflected the control surface through a tab-elevator system. An autotrim command was also generated which drove the stabilizer to reduce the elevator servo loads.

decrease in angle of attack matched the lift increase caused by ground effect. As a result of the flight tests, it was determined that the increment of lift increase caused by ground effects was significantly larger than had been predicted, while the nose-down pitching moment was about as predicted.<sup>2</sup> The result of these tests was a reduction in the autopilot inner-loop gain of 62 percent (see Fig. 5).

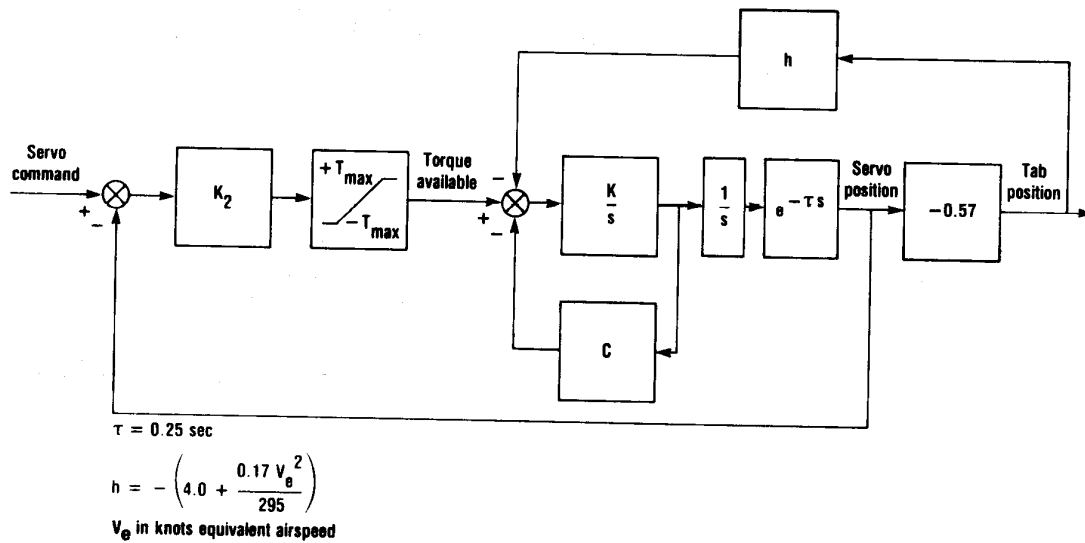
Figure 6. Controlled Impact Demonstration Autopilot Pitch Servo Model

The autopilot servo model used on the simulator is shown in Fig. 6. This model was developed from a comparison of simulation and flight step responses (see Manned Test Flights section).

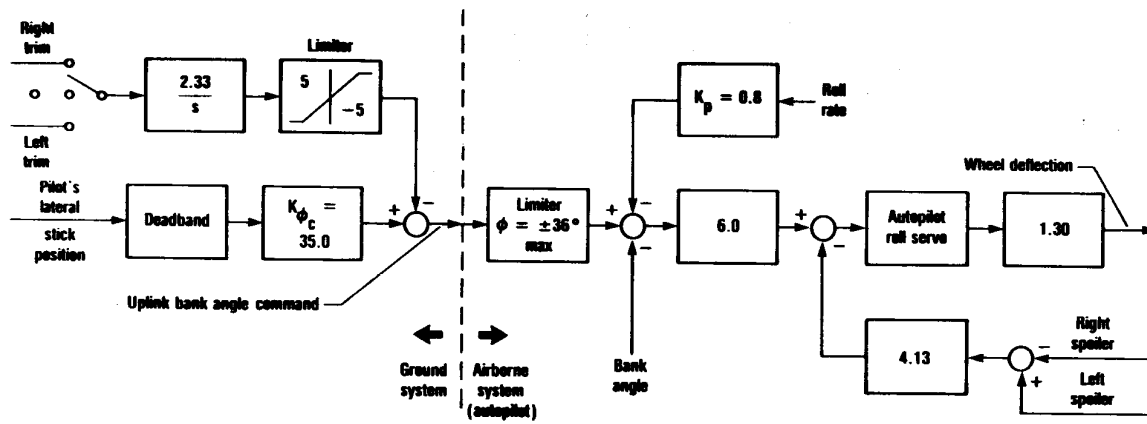
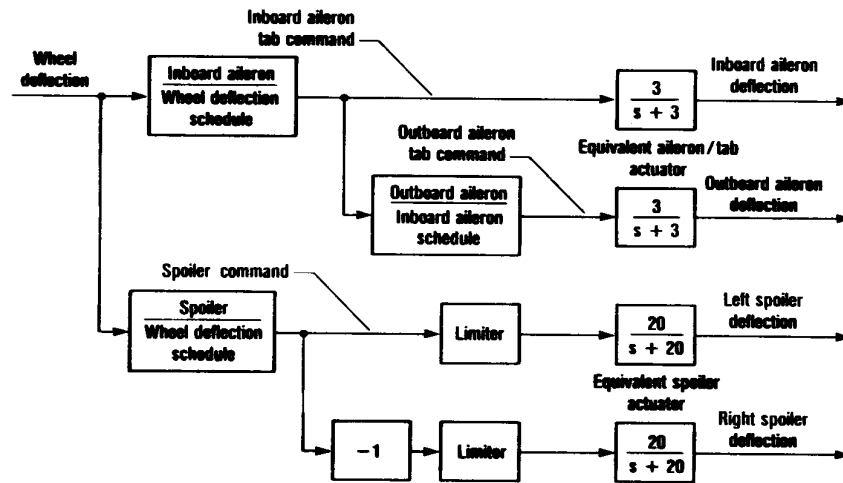
Figure 7. Controlled Impact Demonstration Ground and Airborne Roll Control System

The ground-based and onboard autopilot control laws for the roll axis are shown in Fig. 7. The RPV pilot commanded roll attitude of the aircraft proportional to the lateral displacement of the control stick in the ground-based cockpit. The pilot inputs went through a small deadband and generated commands which were uplinked to the roll axis of the onboard autopilot. Full deflection of the roll stick ( $\pm 10.16$  cm ( $\pm 4$  in.)) commanded  $\pm 35^\circ$  of bank angle.

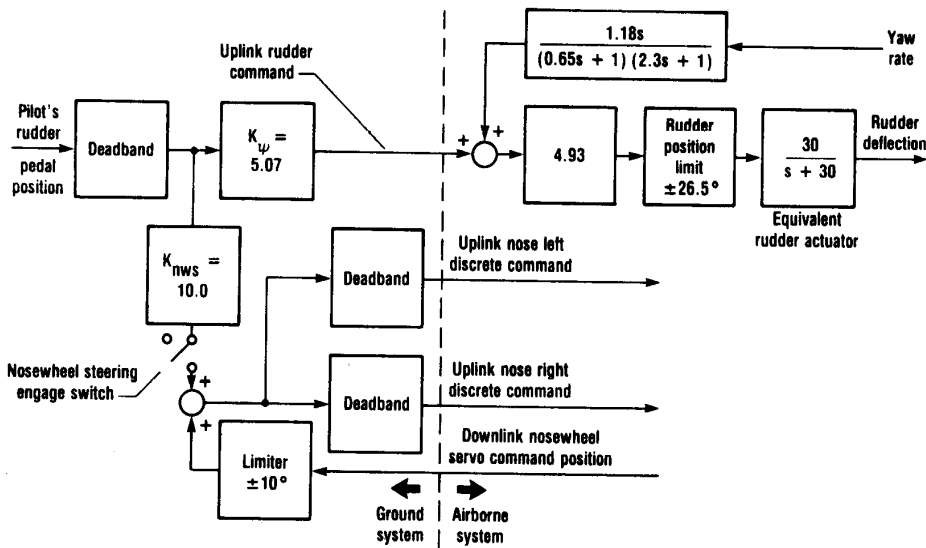
Figure 8. Controlled Impact Demonstration Ground and Airborne Yaw Control System

The RPV pilot commanded rudder to the B-720 aircraft through the yaw damper. The RPV rudder control system is shown in Fig. 8. The rudder pedal position signal was passed through a deadband, and a rudder command proportional to pedal deflection was uplinked to the airplane. Full rudder pedal commanded  $\pm 25^\circ$  of rudder deflection.

A diagram representing the implementation of the ground-based cockpit's nosewheel steering system is also shown in Fig. 8. The RPV pilot generated a nosewheel position command that was proportional to rudder pedal displacement when the nosewheel steering was engaged. This command was then compared to the downlinked nosewheel servo-position command. A nose-left or nose-right discrete command was uplinked to the onboard RPV nosewheel steering system motor. This motor then

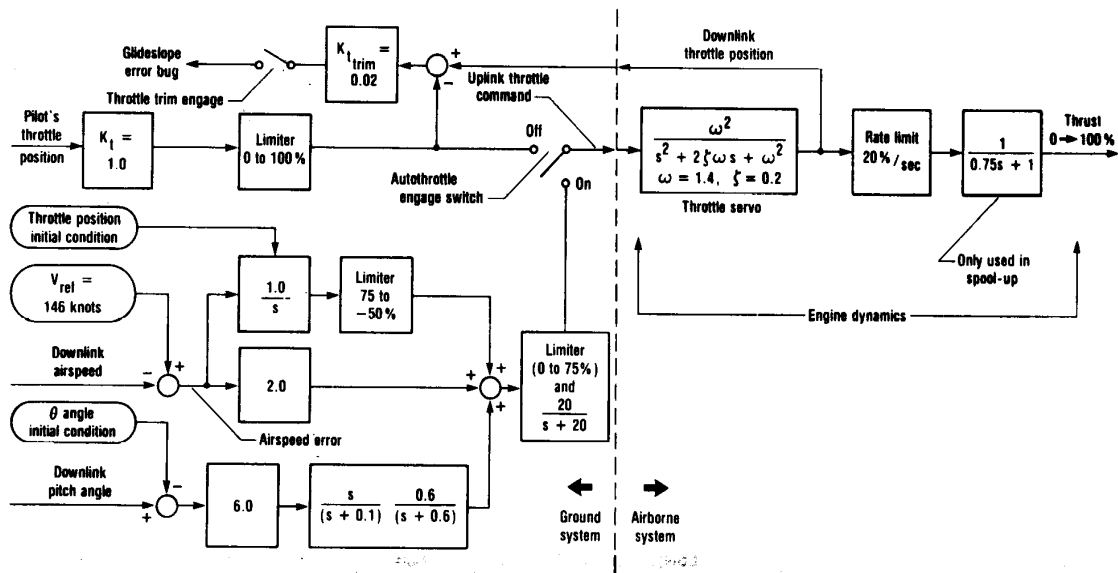
Figure 9. Controlled Impact Demonstration Ground and Airborne Throttle Control System

The RPV pilot commanded the throttle to the airplane through a single lever in the RPV cockpit. An autothrottle was provided in the ground-based software to free the RPV pilot from making throttle adjustments during flight. Figure 9 shows the mechanization of the ground cockpit throttle system, the autothrottle implementation, and the simulation model of the engine dynamics. The throttle was limited to a range between 68-percent engine rpm (idle) and maximum throttle.

The autothrottle was engaged to hold indicated airspeed at a prespecified value. A reference airspeed of 146 knots was selected to obtain the desired true airspeed of 152.5 knots at impact, after passing through ground effect. The airspeed that the autothrottle controlled was the downlinked, onboard-computed airspeed ( $V_{cas}$ ). This downlinked airspeed was compared to the reference airspeed to generate an airspeed error. This error signal was passed through a proportional and an integral path. The integrator was initialized at the current value of the pilot throttle lever position and was limited to a -50 percent to +75 percent range to prevent saturation if the autothrottle was engaged at an airspeed that was significantly different than the reference speed. A filtered, pitch-angle term was used to lead the throttles when the flightpath was changed. The autothrottle command was limited to a range of 0 percent to 75 percent (approximately maximum continuous thrust). This command was uplinked to the B-720 throttle system.

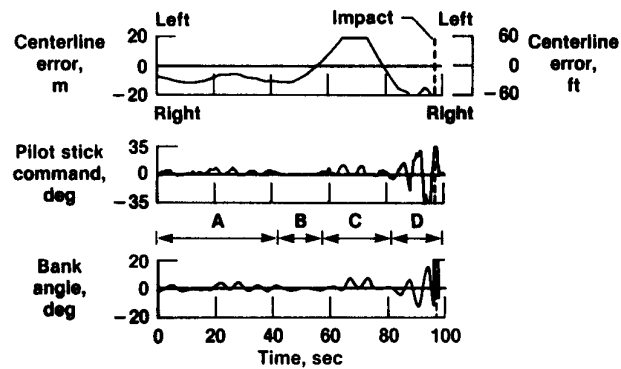
Figure 11. Lateral-Directional Time Response From 498 m (1630 ft) AGL to Impact

Some of the pertinent lateral-directional parameters near impact are shown in Fig. 11 and the longitudinal parameters are shown in Fig. 12. The time histories are broken into four regions (A to D), based on lateral activity, as shown in the figures.

Region B. In region B, the RPV pilot stopped making any significant lateral corrections for about 10 sec. This occurred while he was working the longitudinal task since the altitude error was increasing significantly immediately before region B, and was reduced to an acceptable level by the end of the region B. It could have also been caused, in part, from the need to transition between the TV visual display and the cockpit instruments in order to cross check the validity of the guidance information. Whatever the reason, during this time period without any pilot inputs, the roll bias produced a left turn (about a 2° bank). This, in turn, caused the lateral deviation to start moving rapidly to the left (rapidly in terms of the 4.6 m (15 ft) constraint). The actual crossrange drift rate was about 0.9 m/sec (3 ft/sec) at the end of region B.

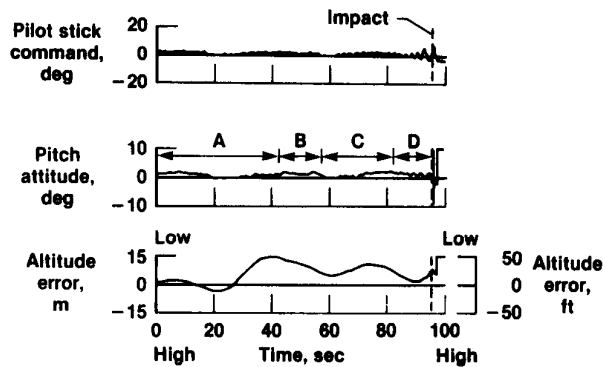
Figure 12. Longitudinal Time Response From 498 m (1630 ft) AGL to Impact

In the pitch axis, the pitch angle was held within the desired range (0 to 2°) during this final region, although it was oscillating. The pitch command was oscillatory and diverging. The altitude error was converging on the desired value until the large bank angles occurred. At this point, altitude was lost because of slight pushover (about 1°) and the lift loss caused by the banking. This resulted in the impact being short of the desired point.
